MOHAWK RIVER WATERSHED
KECKS CENTER CREEK BASIN

CORK CENTER STORAGE RESERVOIR DAM FULTON COUNTY, NEW YORK

NY 658

PHASE I INSPECTION REPORT NATIONAL DAM SAFETY PROGRAM /

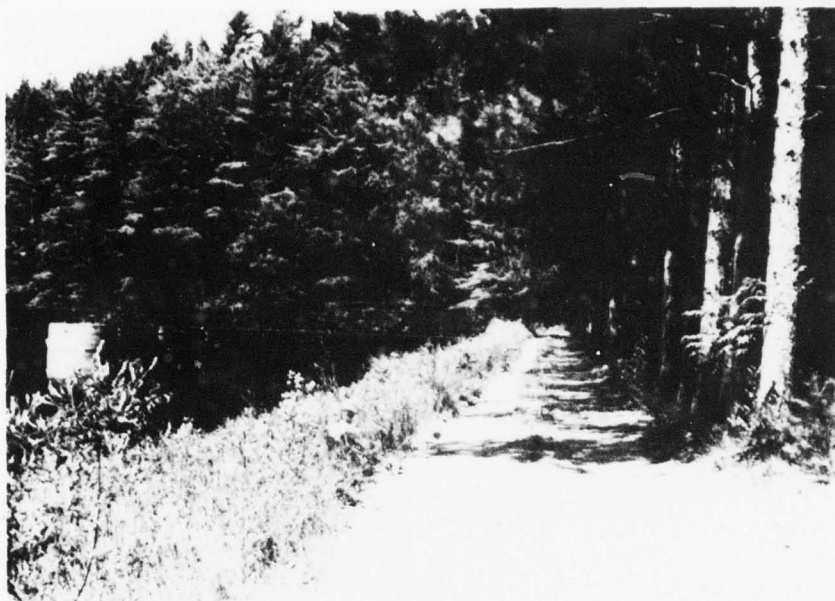
FIGURE 1 CREST OF DAM LOOKING LEFT

The approach road leads to the left abutment of the earthen embankment from whence a 10-foot wide road (Fig. 1, Appendix D) in fairly good condition continues over the crest to the junction of the right abutment with the spillway. Just before the spillway, the embankment takes a 90° turn such that the direction of the spillway is perpendicular to that of the embankment. Over the spillway, there is a 3-foot wide concrete footbridge (Figs. 2 and 3, Appendix D) leading to a small length of embankment, which is heavily wooded and appears to be natural ground.

Near the center of the main embankment, there is an angle-iron access bridge leading to a concrete intake structure (Fig. 1, Appendix D). The access bridge was constructed in 1963, and is generally in good condition but rusted. It needs scraping and painting, but one should be careful to avoid contamination of water with lead compounds or other potentially detrimental material.

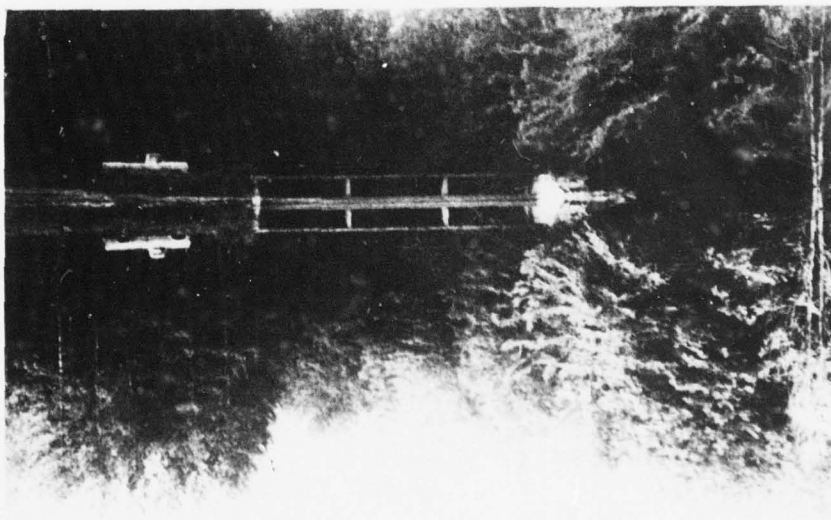
FIGURE 2 SPILLWAY OVERVIEW

i. The overflow section itself (Fig. 2, Appendix D) appears to be in generally good condition with a moderate amount of spalling and erosion of its downstream slope and piers (Fig. 7, Appendix D).

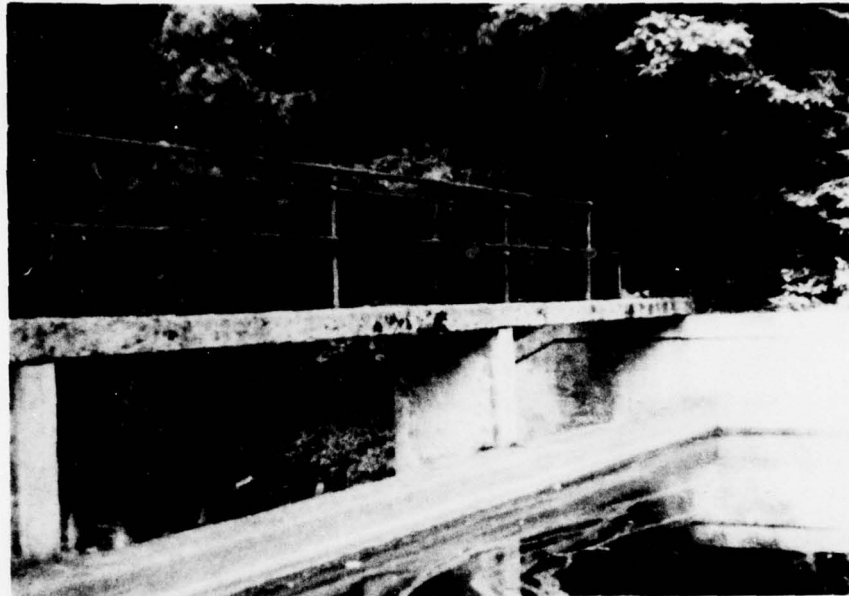
FIGURE 3 SPILLWAY AND RIGHT WINGWALL

iv. The footbridge over the spillway is scaling, with a large spall near the midspan exposing steel (Figs. 3 and 7, Appendix D).

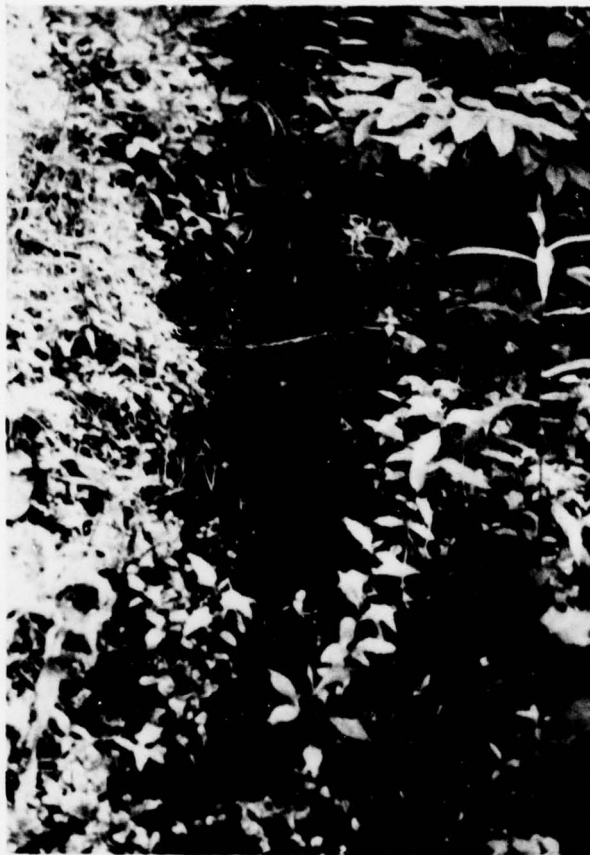
Seepage was observed starting about half-way down the downstream slope of the embankment along its left abutment, continuing along the toe to the right abutment, but does not go up along the crotch of the right abutment. The amount of seepage appears to be substantial, indicating that the cutoff wall is not entirely effective. Although there are indications that this condition has existed for some time and there are no signs of erosion or failure, further investigation is definitely advisable.

FIGURE 5 SEEPAGE AT TOE OF EMBANKMENT

The occurrence of excessive amounts of seepage along the toe of the embankment warrants further investigation. It is recommended that the nature, strength properties and seepage characteristics of the embankment and foundation materials be established through a soil exploratory and testing program. The stability of the embankment may then be analyzed in the light of the new findings, and any necessary measures to reduce or control flow established.

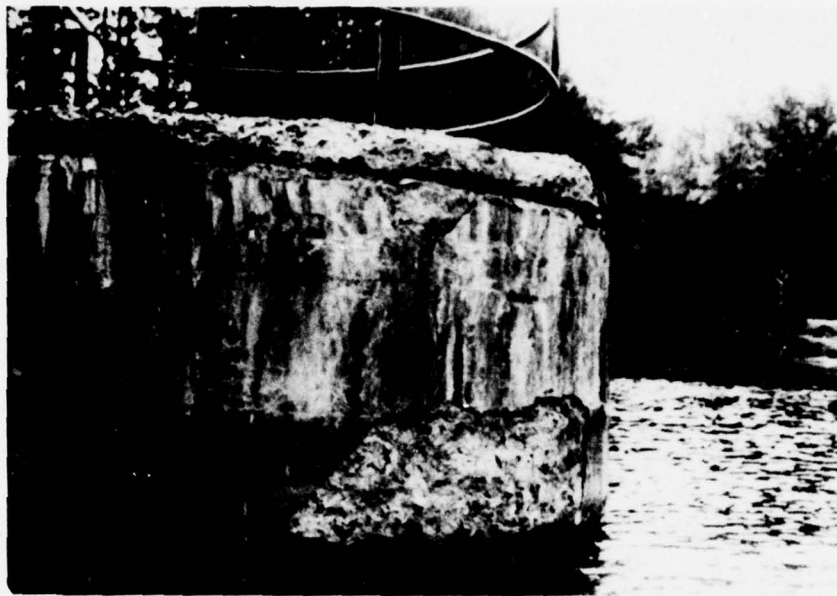
The access bridge to the intake structure is rusted and does not appear to have been painted since installation in 1963. The gate platform at the intake structure is moderately spalled and scaled. Valve stems at the intake structure and gate house turned, and were observed to function very well with little or no slack. At the outfall, the metal pipes appear to be in good condition. The lower gate house floor is a little wet from seepage into the house, but pipes and valves under the floor look good and dry. There is no lighting arrangement at the lower gate house.

FIGURE 13 SPALLING AND SCALING OF THE INTAKE STRUCTURE

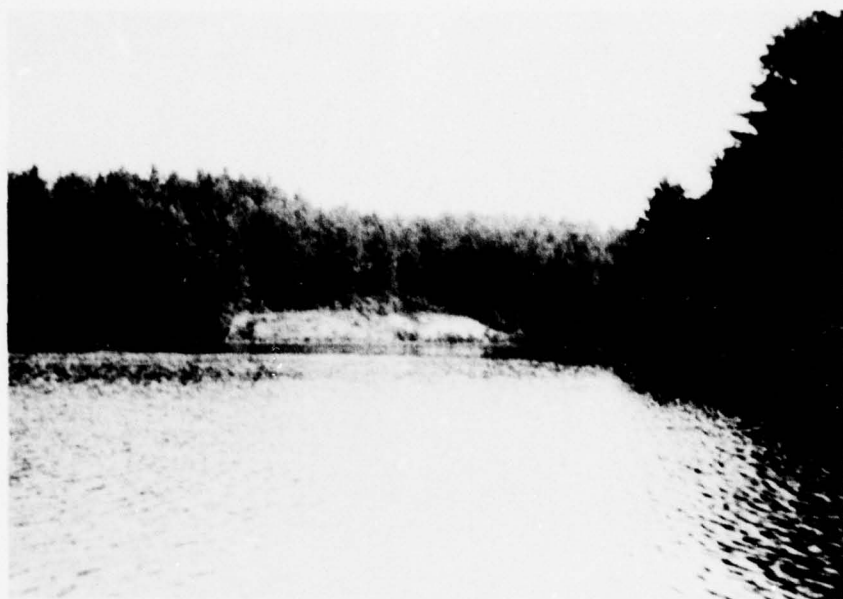
FIGURE 15 RESERVOIR SIDE SLOPES

The reservoir area is heavily wooded except for one naturally sandy area that is covered with moss and scrub only (Fig. 15, Appendix D). Side slopes of the reservoir are steep; about $1\frac{1}{4}$ horizontal to 1 vertical. However, there is no evidence of slope failure. There is a moderate amount of sedimentation at the upstream entrance and an indication of sedimentation at the dam, suggested by the turbidity of water released from the mud pipe.
